O A L S BULLETIN 11

AN ASSESSMENT OF THE IMPACT OF
WATER IMPOUNDMENT AND DIVERSION STRUCTURES
ON VEGETATION IN SOUTHERN ARIZONA

OFFICE OF ARID LANDS STUDIES
University of Arizona
Tucson, Arizona

December 1975

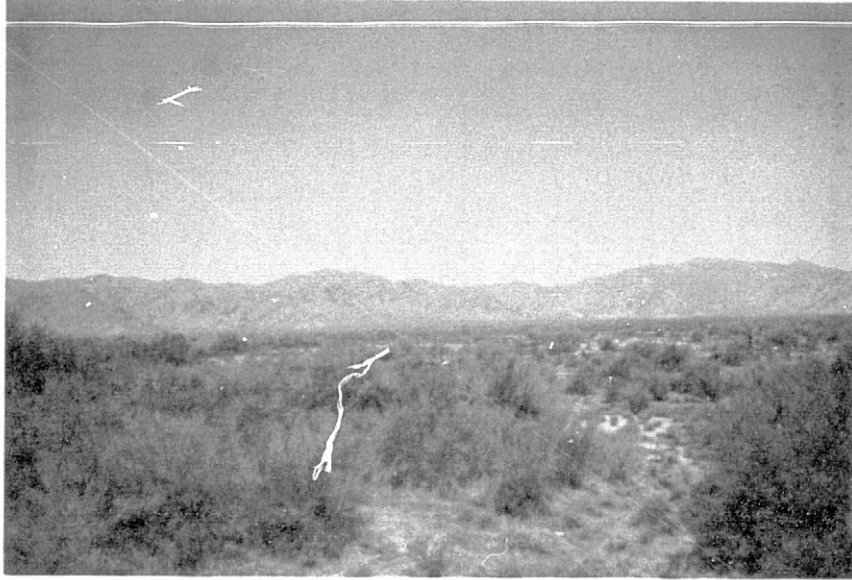
Figure 8. Ground truth photo of upslope vegetation (Structure #3).

Species composition of the vegetation upslope and downslope from the diversion structure is the same: foothill paloverde, creosote bush, and triangle-leaf bursage on the interfluves, and mesquite, ironwood, and blue paloverde along the washes. Vegetation density and vigor are quite different for the two areas however. Figure 7 (a photo of the downslope vegetation) when compared to Figure 8 (a photo of upslope vegetation) illustrates this difference. The vegetation upslope appears to be much more luxuriant and vigorous than downslope.

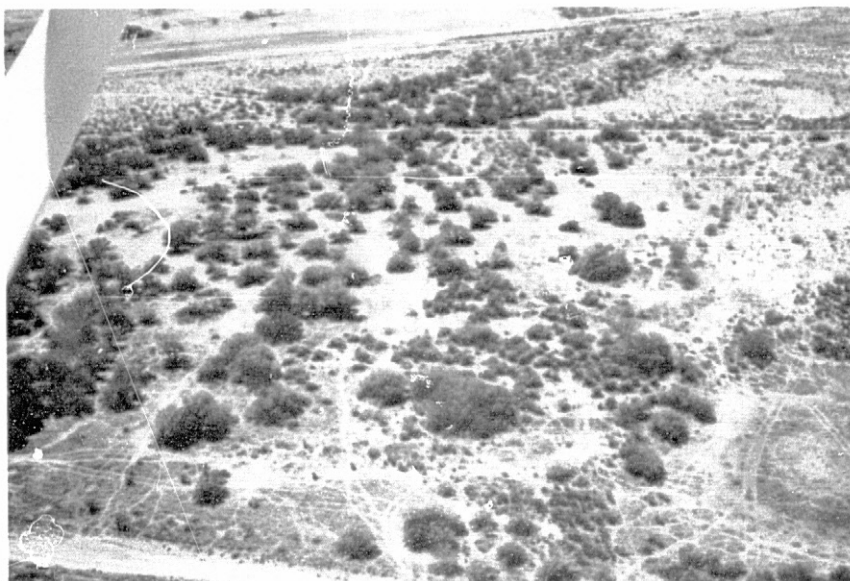
Figure 12. Infrared low-altitude photo of upslope vegetation (Structure #4).

Associated with the riparian vegetation upstream is a high cover and density. Cover and density of downslope vegetation is quite low in comparison. Figures 10, 11, 12, and 13 (ground truth and infrared low-altitude photographs of the upslope and downslope areas) illustrate the upslope/downslope vegetation cover and density difference.

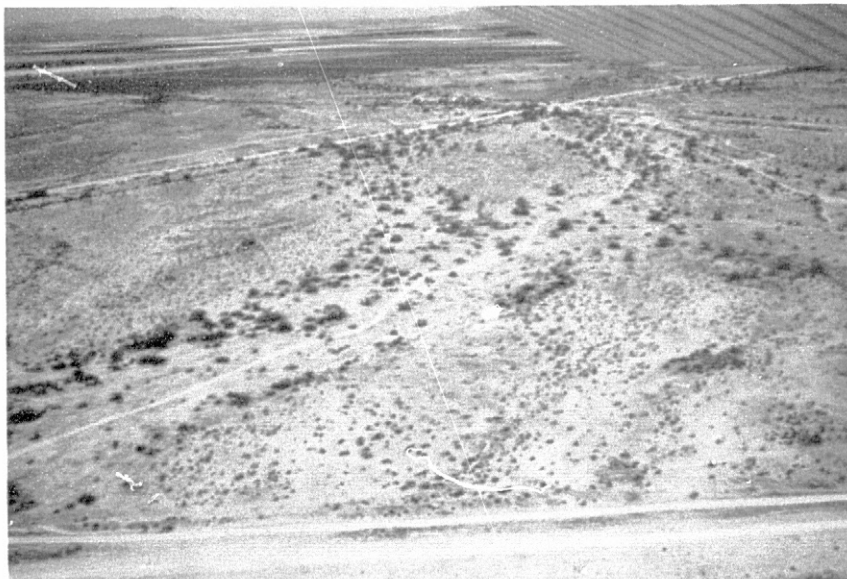
Figure 13. Infrared low-altitude photo of upslope vegetation (Structure #4).

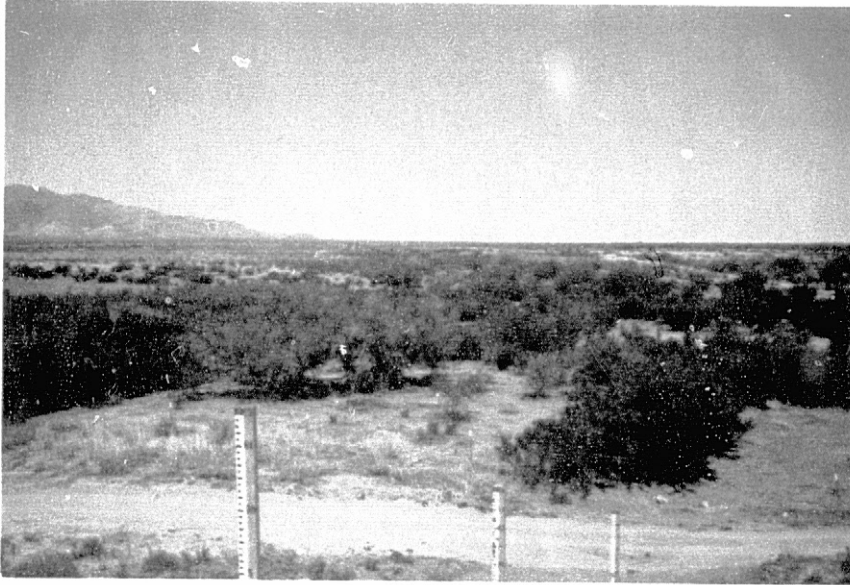
Figure 16. Mesquite/Blue Palo Verde type upslope from the structure (#5).

Upslope, in the areas of deepest seasonal standing water, there occurs a very dense stand of seep-willow (shown in Figure 15). Further upstream, wash vegetation is primarily the Mesquite/Blue Paloverde type as shown in Figure 16. Interfluvial vegetation is the Triangle-Leaf Bursage/Creosote Bush type.

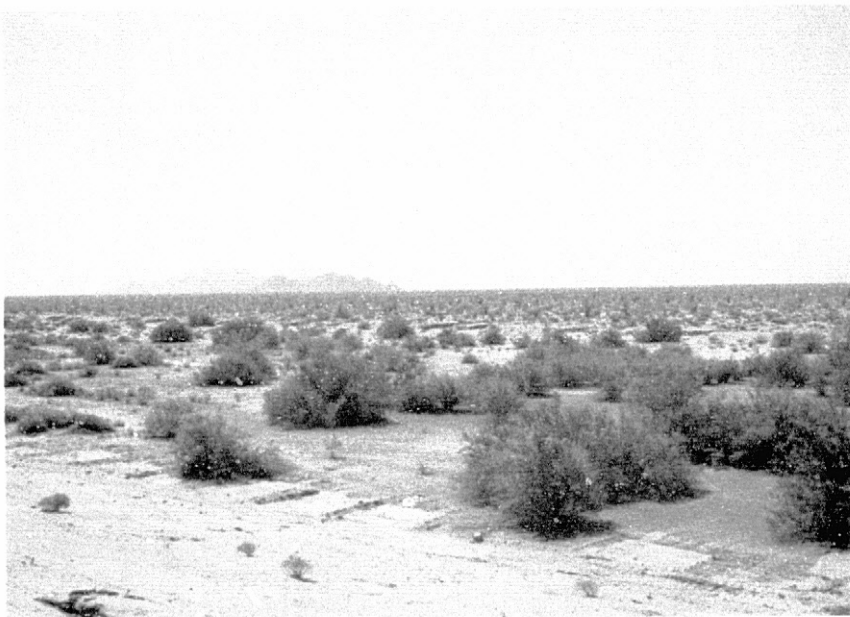
Figure 20. Ground truth photo of upslope vegetation (Structure #6).

In general, downslope and upslope vegetation is the same in species composition, density, cover, and vigor. Upslope, however, there is an increase in the before-mentioned vegetation parameters immediately adjacent to the highway. Downslope, at culverts, the vegetation is locally luxuriant and vigorous. Figures 20 and 21 (photos of upslope and downslope vegetation) and Figure 22 (an aerial infrared photo of the highway and areas upslope and downslope) show the differences in vegetation

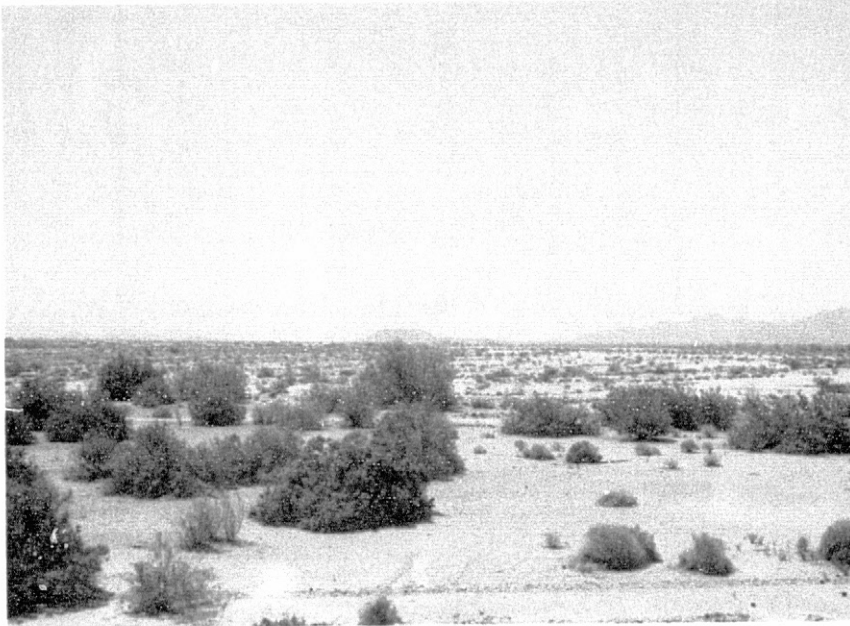
Figure 21. Ground truth photo of downslope vegetation (Structure #6).

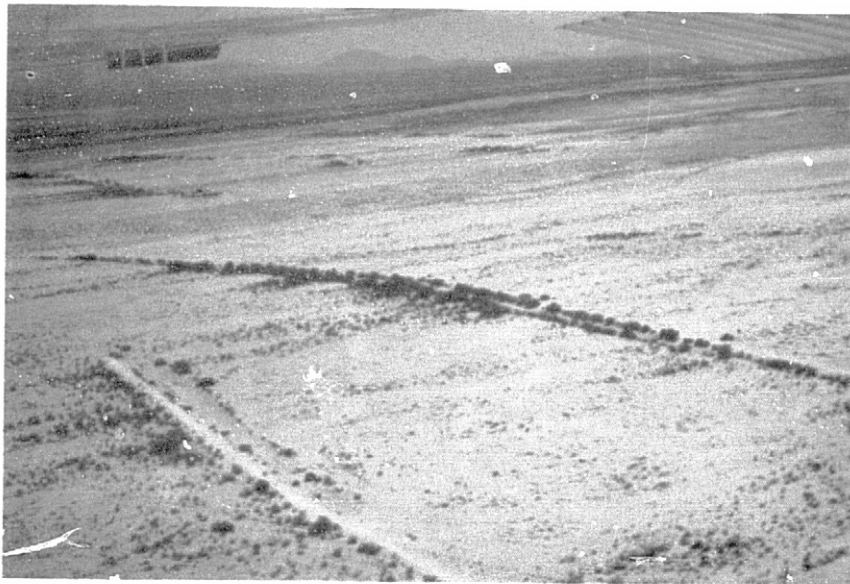
Figure 25. Infrared aerial photo of two downstream diversion structures (#7).

Figure 24 is an aerial view of the same structure. Figure 25, an aerial view of two diversion structures further downstream, when compared to Figure 24, illustrates the reduced impact on vegetation of structures furthest downstream in the series.

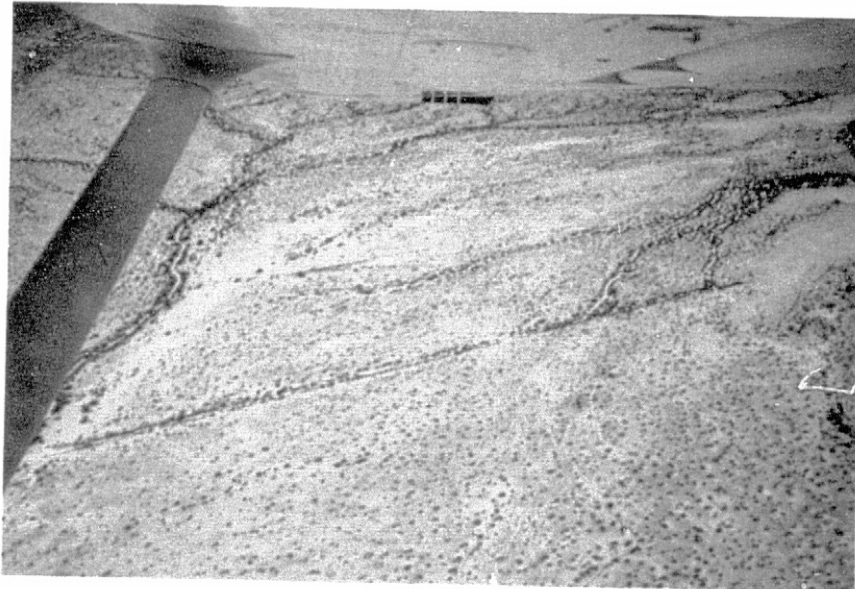
Figure 33. Infrared aerial photo of one of the structures (#10).

Vegetation both upslope and downslope from the structures consists of the Creosote Bush type with scattered mesquite and cholla. Mesquite is abundant along the upslope edge of the diversions. Cover and vigor of vegetation upslope and downslope from the structures has been little affected. Figure 33, an aerial photo of one of the structures, shows how it has possibly affected the alteration of water courses.

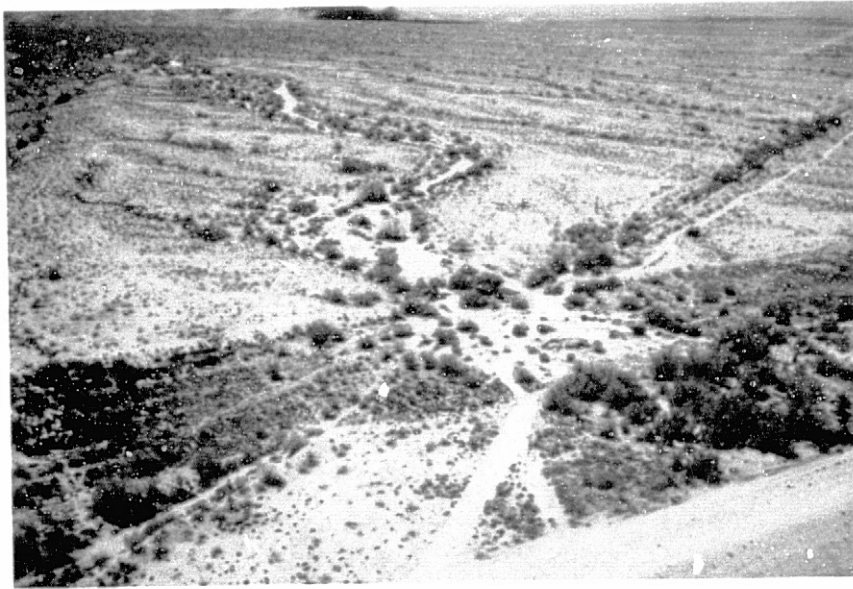
Figure 34. Infrared low-altitude photo of the diversion structure and upslope-downslope vegetation (Structure #11).

As is shown by Figure 34 (an aerial photo of the site) and Figure 35 (the vegetation map of the site) vegetation patterns are similar upslope and downslope, except for a narrow band of dense vegetation immediately upslope from the structure.

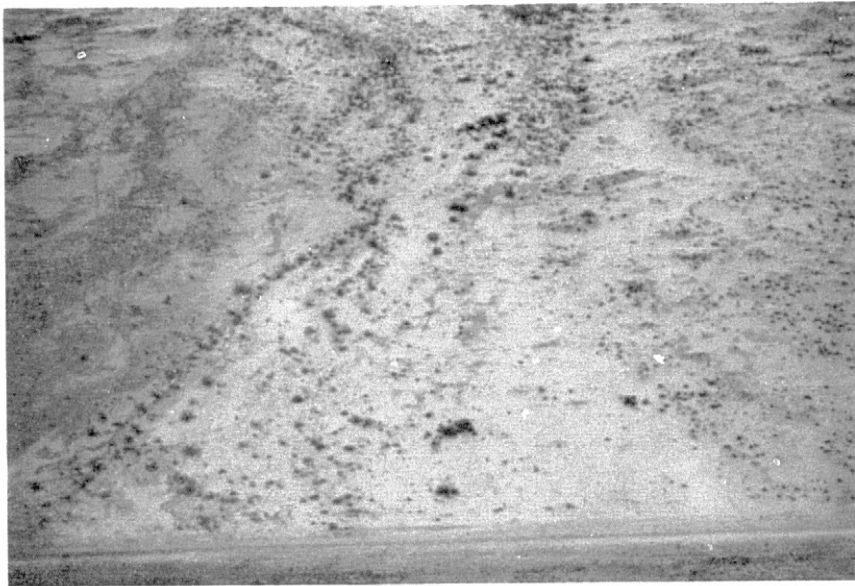
Figure 40. Infrared aerial photo of downslope vegetation (Structure #13).

The vegetation upslope and downslope from the structure consists of the Creosote Bush type on the interfluves and the Mesquite type along the washes. Generally, the vegetation upslope is more vigorous and has higher cover than the vegetation downslope. As is illustrated by the comparison of Figure 40 (infrared aerial photo of downslope vegetation) to Figure 41 (infrared aerial photo of upslope vegetation), riparian vegetation upslope is much more dense and vigorous than downslope vegetation. Some of the riparian stands upstream are bosque-like in character while most riparian vegetation downstream is sparse and impoverished. Interfluve vegetation exhibits a smaller upslope-downslope difference in the aforementioned parameters than does riparian vegetation.

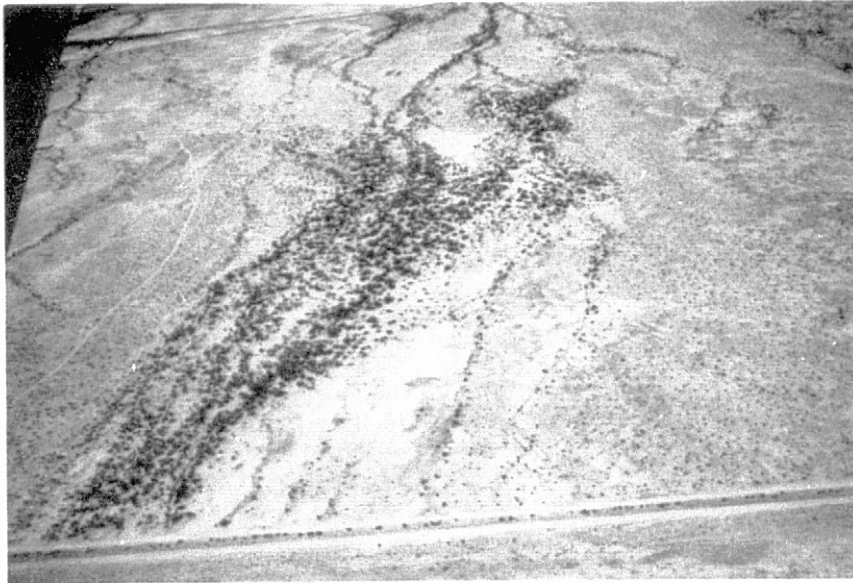
Figure 43. Infrared low-altitude photos of upslope vegetation (Structure #14).

The vegetation upslope and downslope from the structure consists of the Creosote Bush type on interfluves and the Mesquite or Mesquite/Ironwood type along watercourses. The cover and vigor of the upslope vegetation is higher than that of downslope vegetation. Riparian vegetation downslope is severely stressed, while upslope it is quite vigorous. Figures 43 and 44 (color-infrared aerial photos of upslope and downslope vegetation, respectively) show the difference between upslope and downslope vegetation.
